NIANTIC RIVER BASIN
WATERFORD, CONNECTICUT

LAKE KONOMOC DAM
CT. 00152

PHASE I INSPECTION REPORT
NATIONAL DAM INSPECTION PROGRAM

JUNE 1979

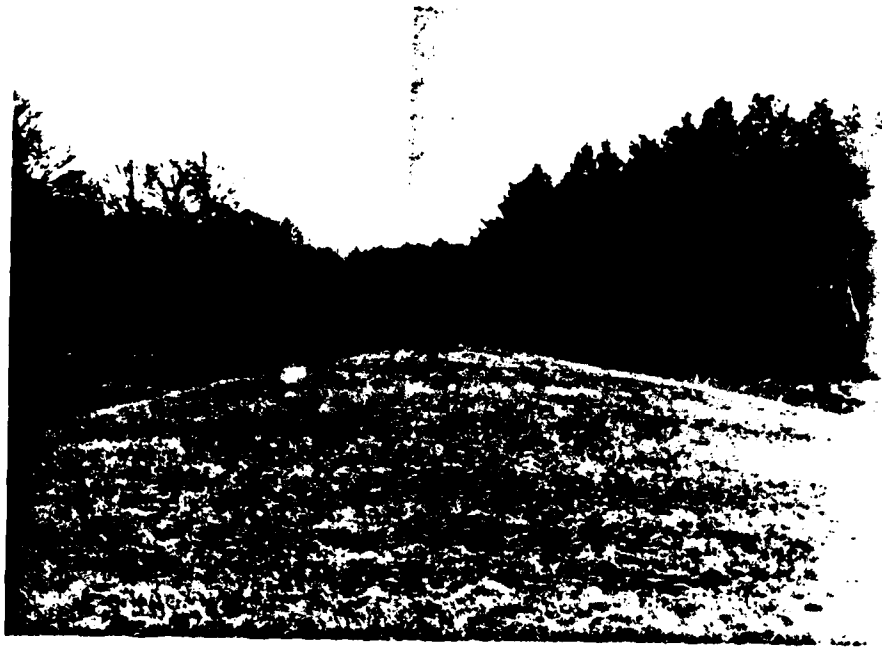
3. Right Abutment Dike. No seepage was observed along the toe of the right abutment dike, which is in a similar condition to the main dam (see Photo No. 5, Appendix C).

5. View along crest of right abutment dike.

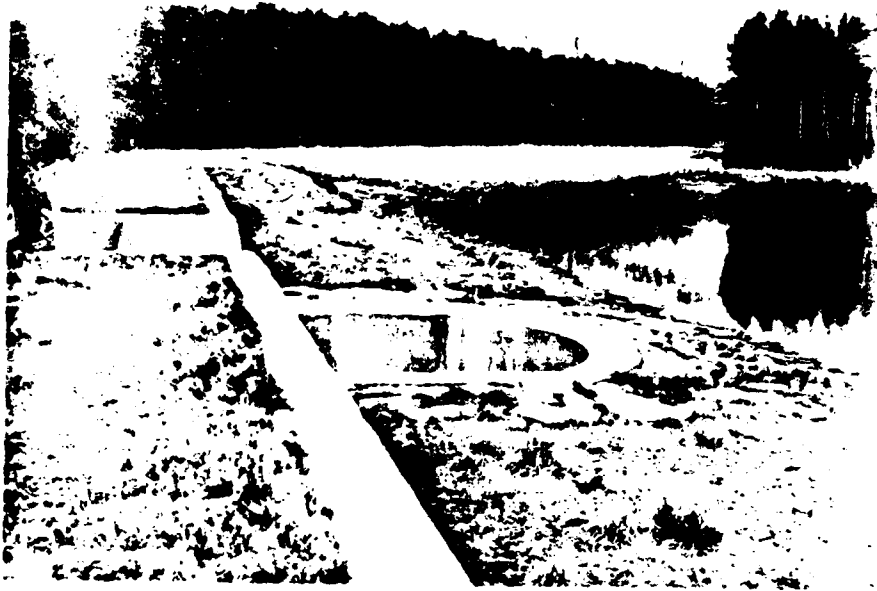
transported a slight but steady flow across its width leading either ground water intrusion through defective concrete slabs, or release of rain water or spillway flow retained in the 3.5 ft. thick boulder in the stilling basin. However, the "as-builts" indicate the joints of the spillway to have been equipped with rubber waterstops; there are no weep holes and little or no precipitation is said to have occurred for some period before the inspection. Site personnel stated that this moisture has been evident almost from the completion of construction (see Photo Nos. 11, 12, 13 and 14, Appendix C).

11. Overview of spillway crest.
